# INDOOR AIR QUALITY REASSESSMENT

**Department of Revenue  
Child Support Enforcement Division  
239 Causeway Street  
Boston, Massachusetts**

Prepared by:  
Massachusetts Department of Public Health  
Bureau of Environmental Health Assessment  
August 2002

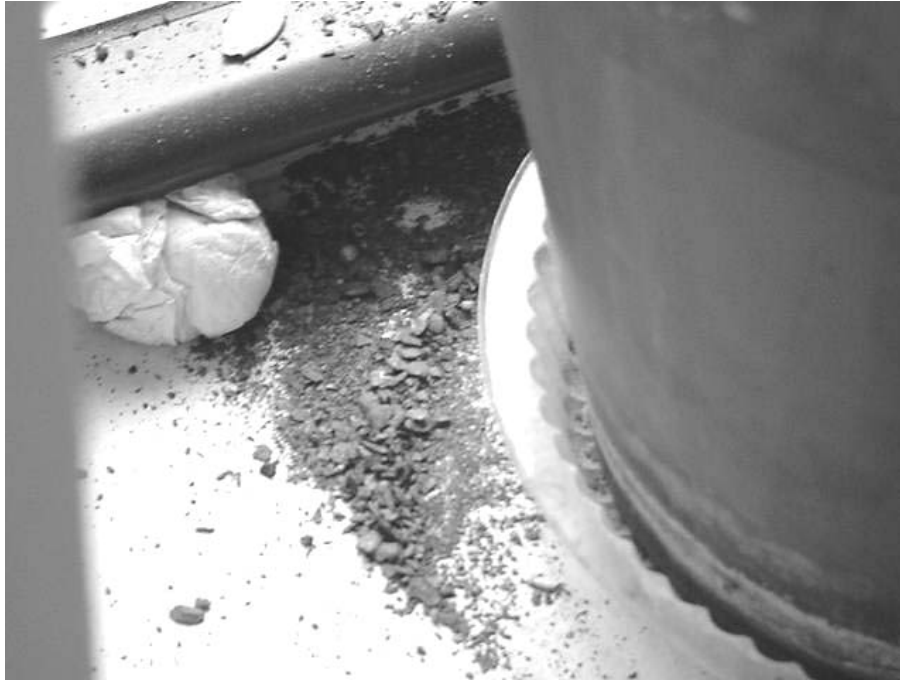
**Picture 1**

Several areas had a number of plants. In some areas potting soil was observed on flat surfaces surrounding plants (see Picture 1). The plant in Picture 2 was sitting in standing water, which can become stagnant, providing a source of microbial growth and associated odors.

**Potting Soil on Flat Surfaces around Plant**

3. Avoid over watering of plants. Ensure flat surfaces around plants are free of potting soil and other plant debris. Consider reducing the number of plants in some areas. Examine drip pans periodically for mold growth and disinfect with an appropriate antimicrobial where necessary.

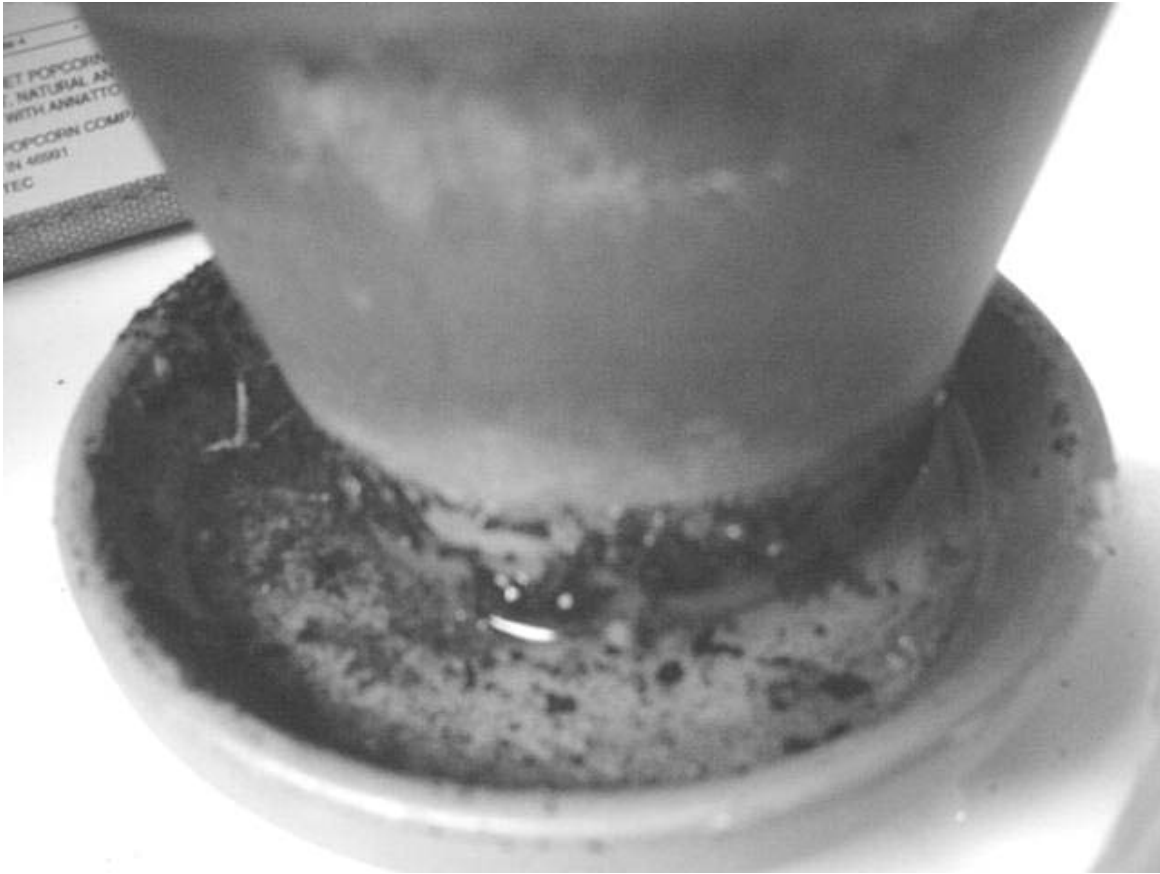
**Picture 2**

**Plant in Standing Water**

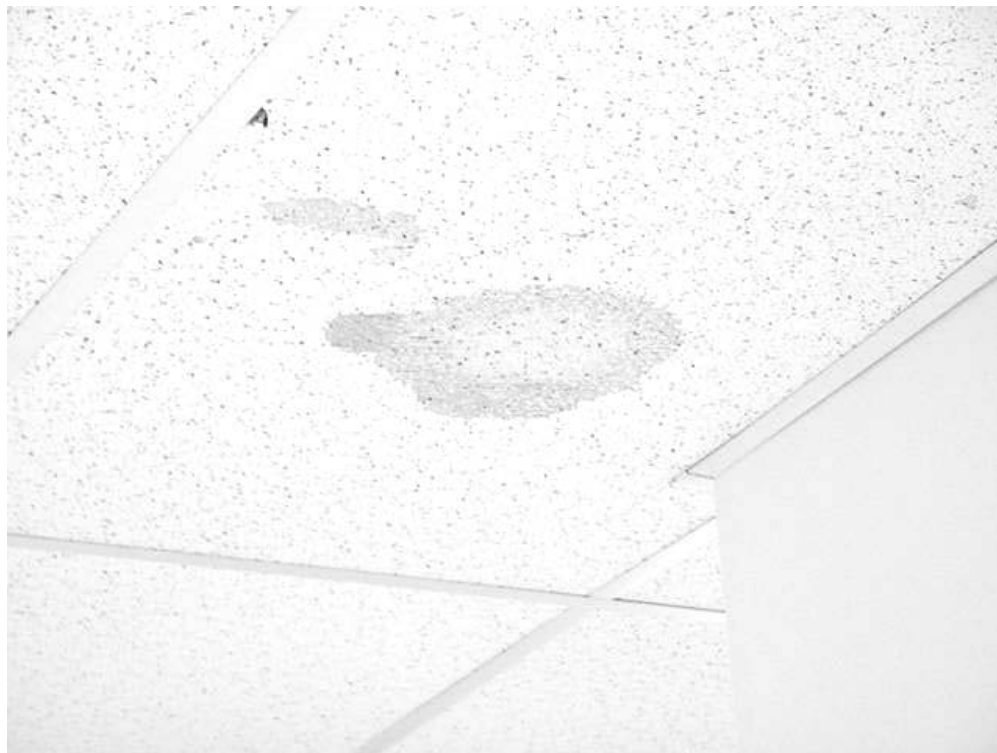
**Picture 3**

Water damaged ceiling tiles were observed in area 379, near the support beam and in the hallway outside of the women's restroom (see Picture 3). Water-damaged ceiling tiles can provide a source of microbial growth and should be replaced after a water leak is discovered.

**Water Damaged Ceiling Tiles in Area 379**

2. Replace any remaining water-stained ceiling tiles or other water damaged building materials. Examine above and around these areas for microbial growth. Disinfect areas of water leaks with an appropriate antimicrobial as needed.

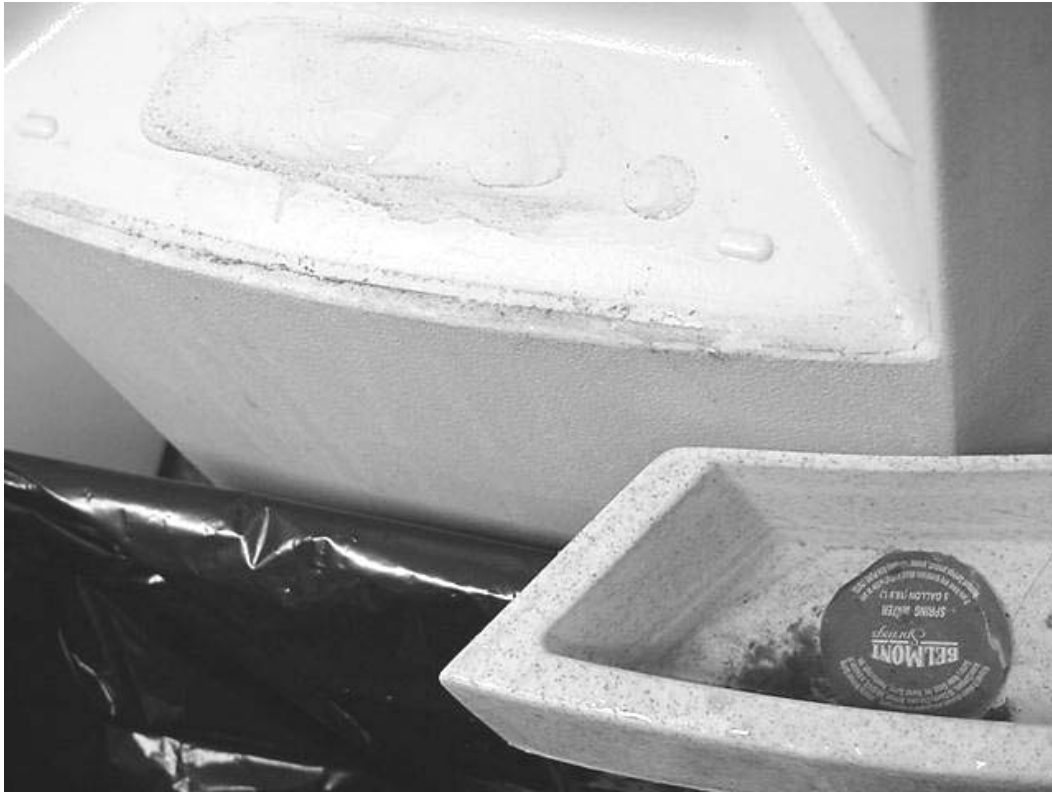
**Picture 4**

A number of areas had water coolers, water fountains and small refrigerators installed over carpeting. Water spillage or overflow of cooler catch basins can result in the wetting of the carpet. Residue/build-up in the reservoirs of water coolers was also observed (see Picture 4). These reservoirs are designed to catch excess water during operation and should be emptied/cleaned regularly to prevent microbial and/or bacterial growth.

**Black Residue/Possible Mold Growth in Water Cooler Catch Basin**

4. Relocate or place tile or rubber matting underneath water coolers and refrigerators in carpeted areas.
5. Continue to implement improved dust control methods such as wet wiping and HEPA vacuuming. Due to security measures and time constraints, a coordinated effort between, DOR management, DOR staff, building management and maintenance personnel should be made to conduct cleaning of offices, common areas and cubicles/personnel work spaces to prevent the accumulation of settled dust.

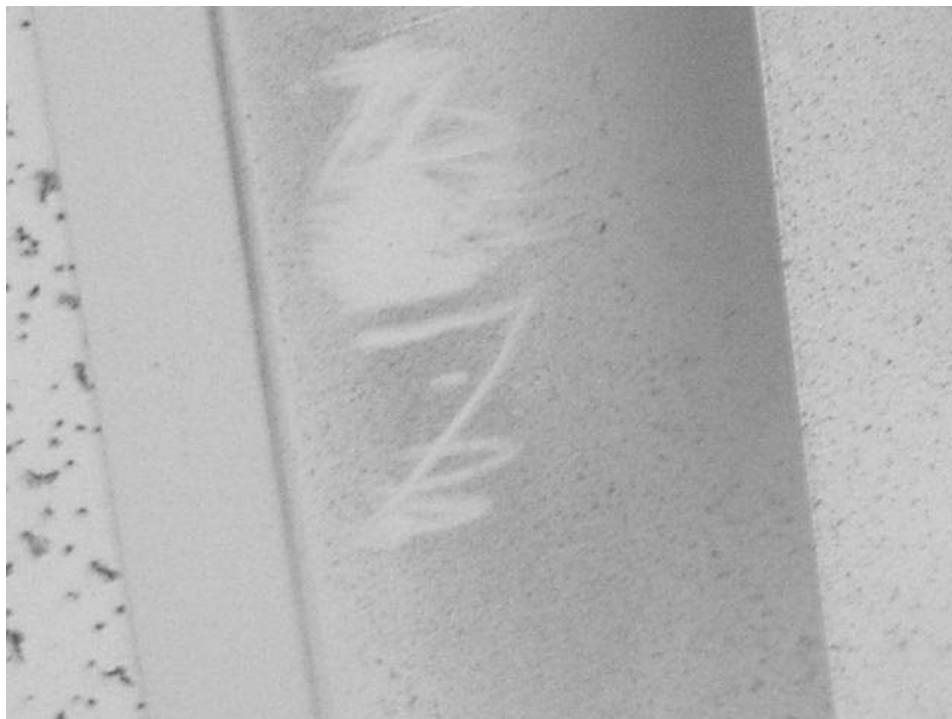
**Picture 5**

Several conditions that can potentially affect indoor air quality were also identified. Accumulated dust was noted on air diffusers and on flat surfaces throughout the DOR space (see Picture 5). Dust can be irritating to the eyes, nose and respiratory

**Accumulated Dust on Flat Surface**

6. Discontinue the use of VOC-containing cleaners and air fresheners. Less irritating materials, (soap and water) may suffice to clean in these areas.
7. Clean supply and return diffusers periodically of accumulated dust.

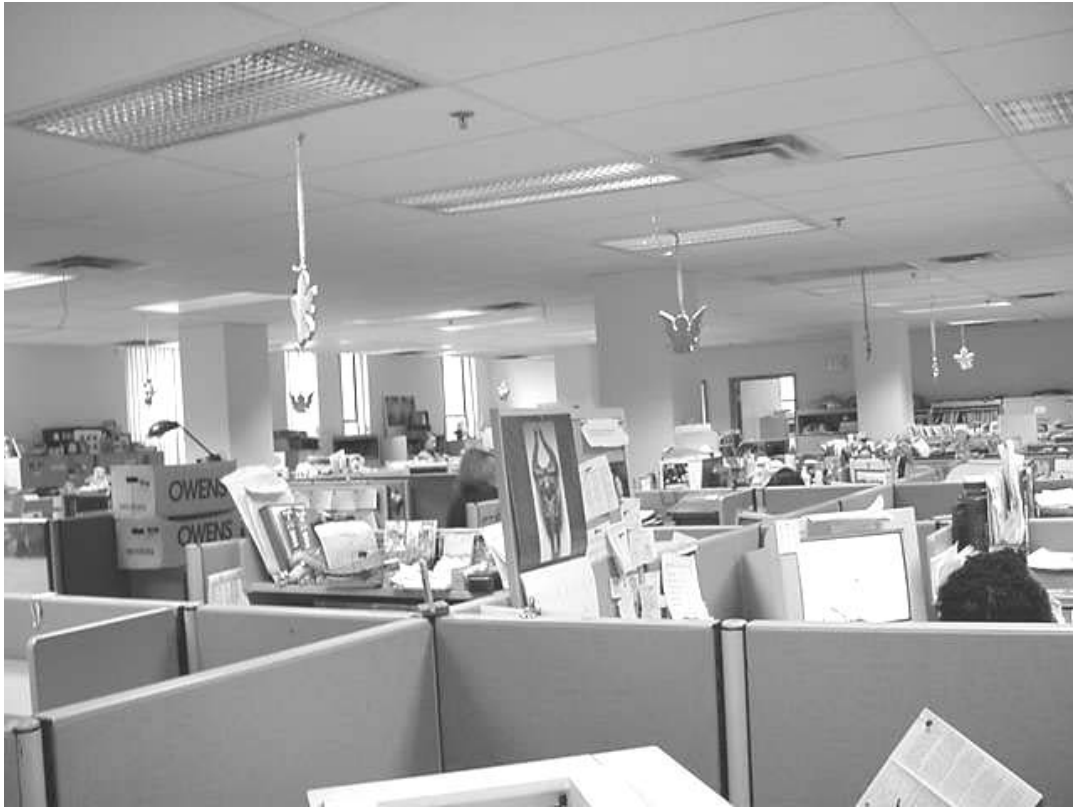
**Picture 6**

tract. The large amount of items stored provides a means for dusts, dirt and other potential respiratory irritants to accumulate (see Pictures 6 & 7). These stored items, (e.g., papers, folders, boxes, etc.) make it difficult for custodial staff to clean. Of particular note are items hanging from ceiling tiles.

**Accumulated Materials and Items Hanging From Ceiling Tile System**

8. Refrain from hanging objects from ceiling tile system.

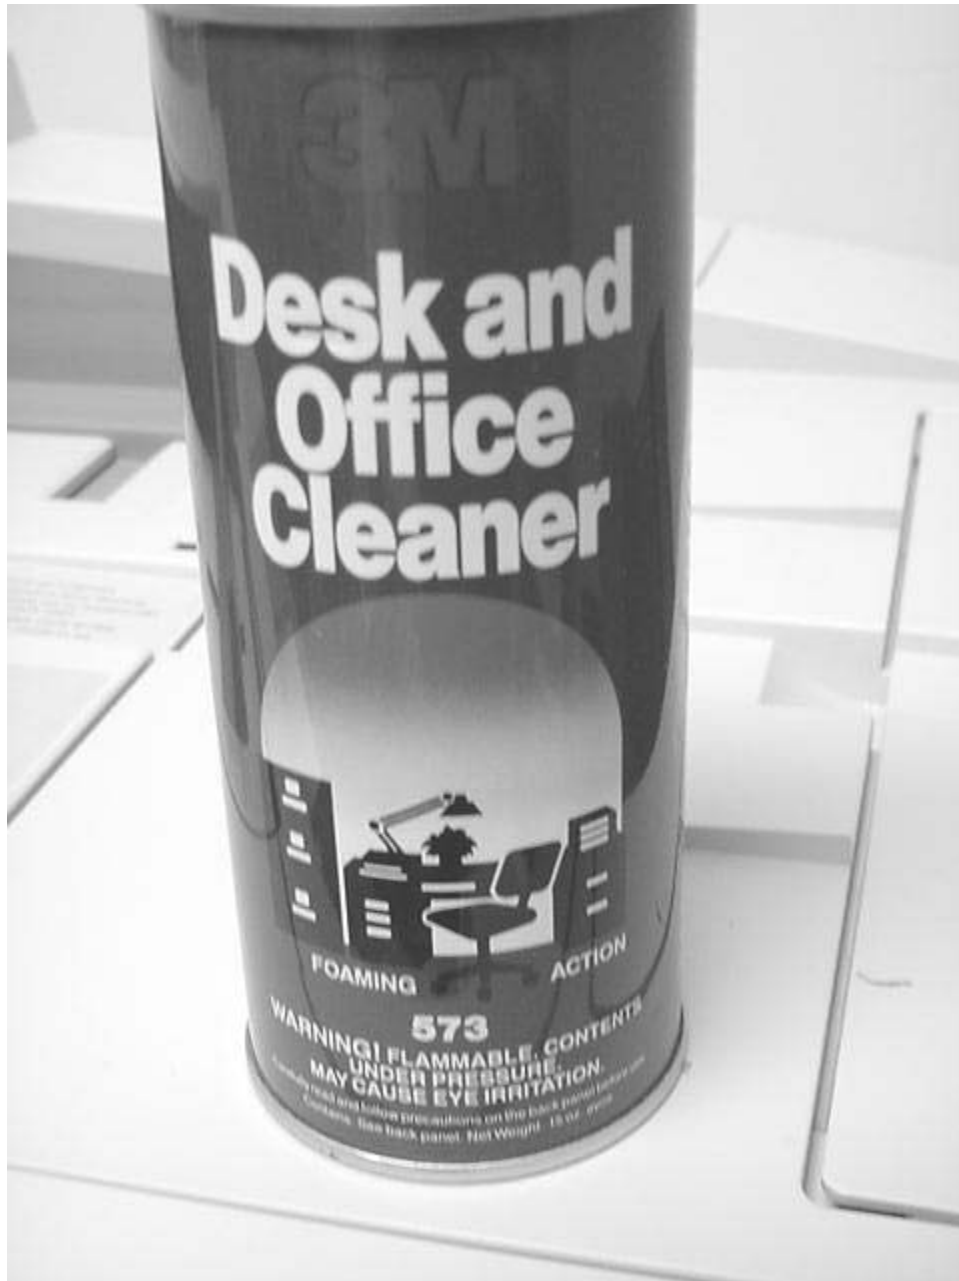
**Picture 7**

Lastly, DOR staff frequently use VOC-containing cleaning materials (see Picture 7) to clean their personal work areas. This material contains several VOCs (e.g., isopropyl alcohol and monoethanolamine) that can be irritating to the eyes, nose and throat (3M, 2000). These conditions, in combination with those discussed earlier (e.g., cleaning during work hours, accumulated items) if considered individually present conditions that could degrade indoor air quality. When combined, these conditions can serve to exacerbate conditions leading to eye irritations and other indoor air quality comfort complaints.

**VOC-Containing Cleaning Material Used by DOR/CSE Employees**
